1111 N. West Shore Boulevard, Suite 502  
Tampa, FL 33607-4529  
Tel: (813) 228-8212  
JMannix@karins.com

April 14<sup>th</sup>, 2023

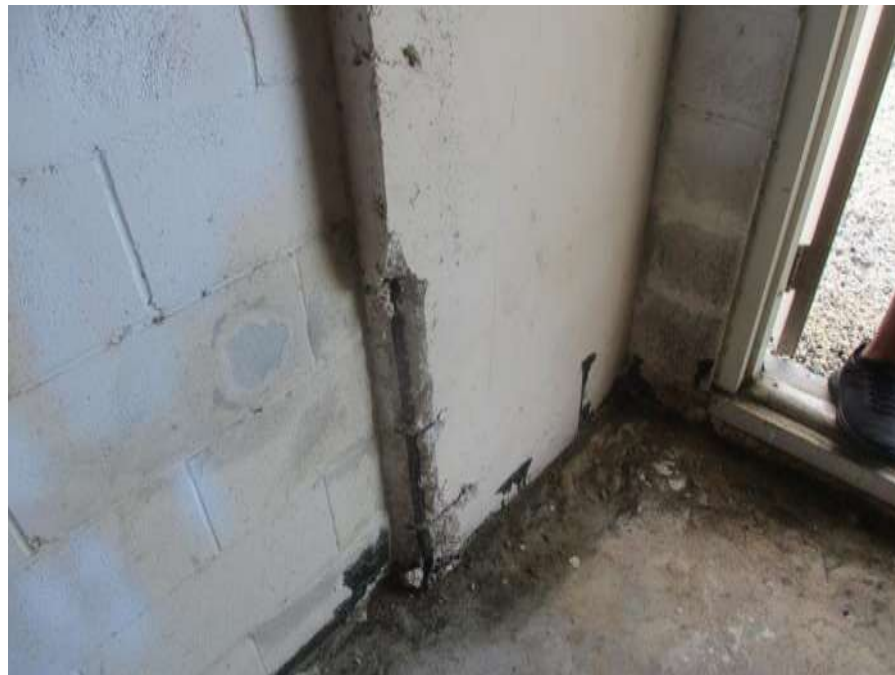
**Photo #6** – Spalling Concrete at Storage/Electrical Room at Roof

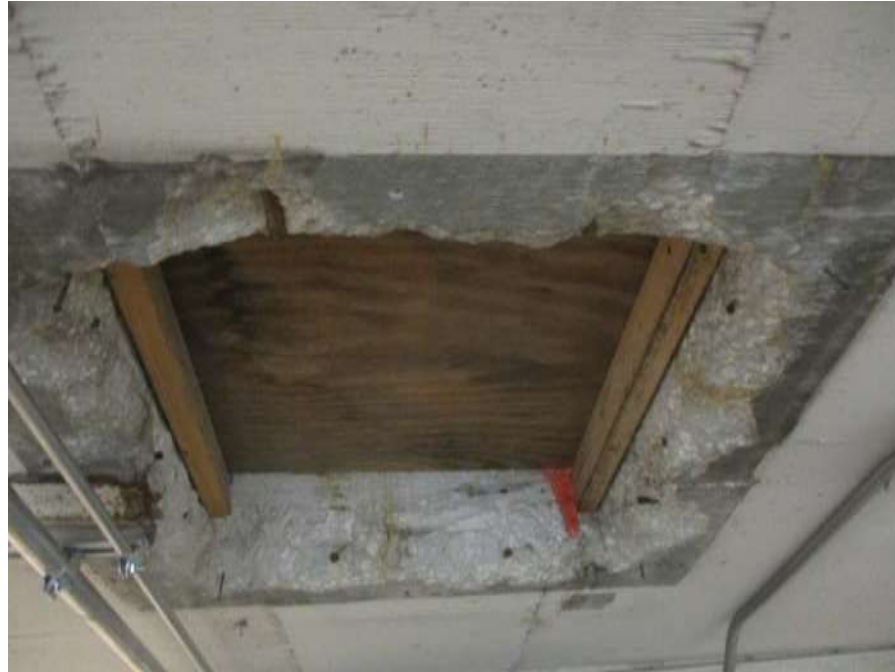
**Photo #7** – Roof Access Closed off with Wood Framing with Spalling Concrete and Signs of Water Intrusion

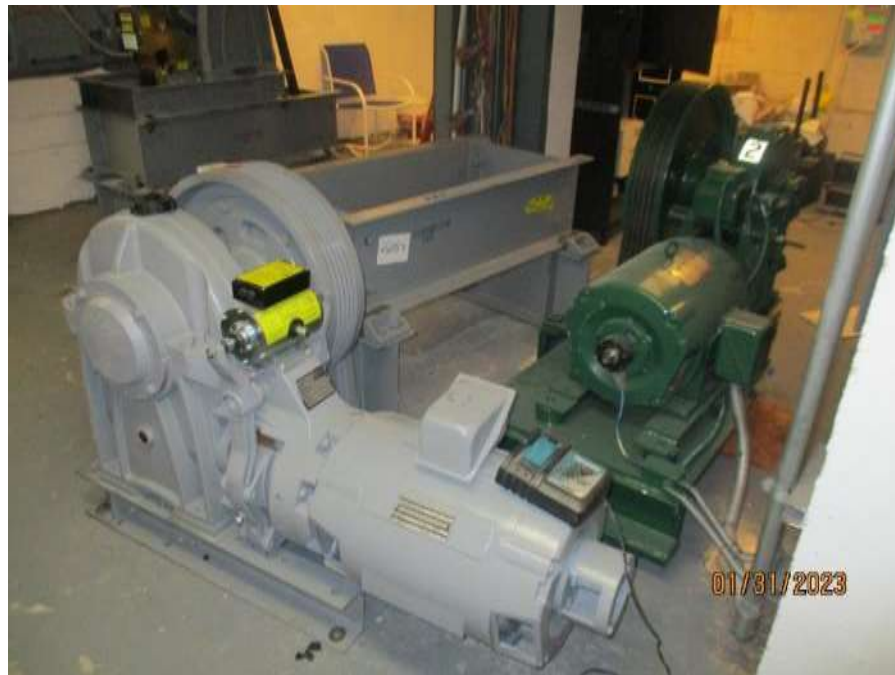
**Photo #8** – In Progress Elevator Equipment Replacement

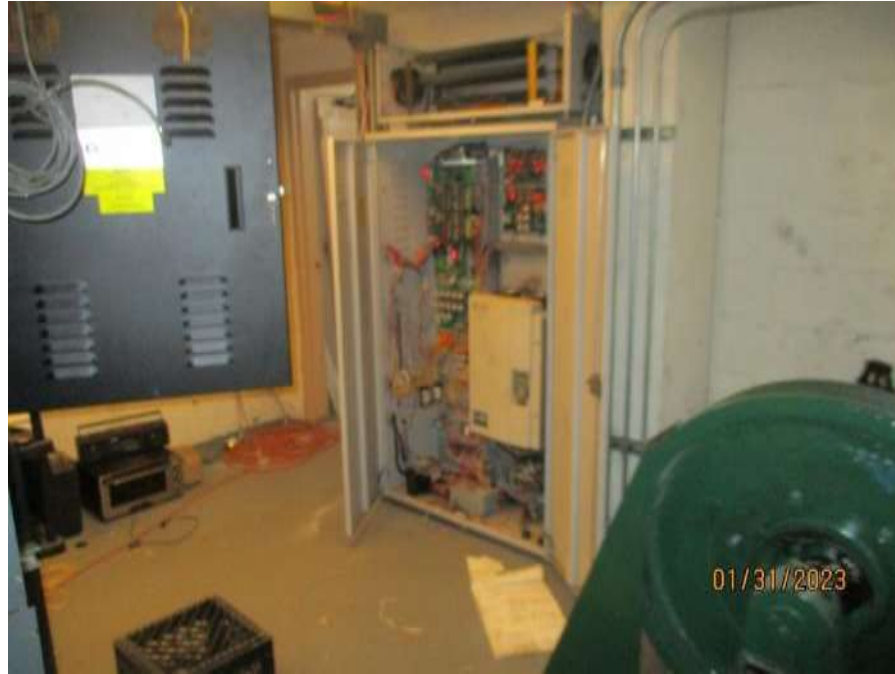
**Photo #9** – In Progress Elevator Equipment Replacement

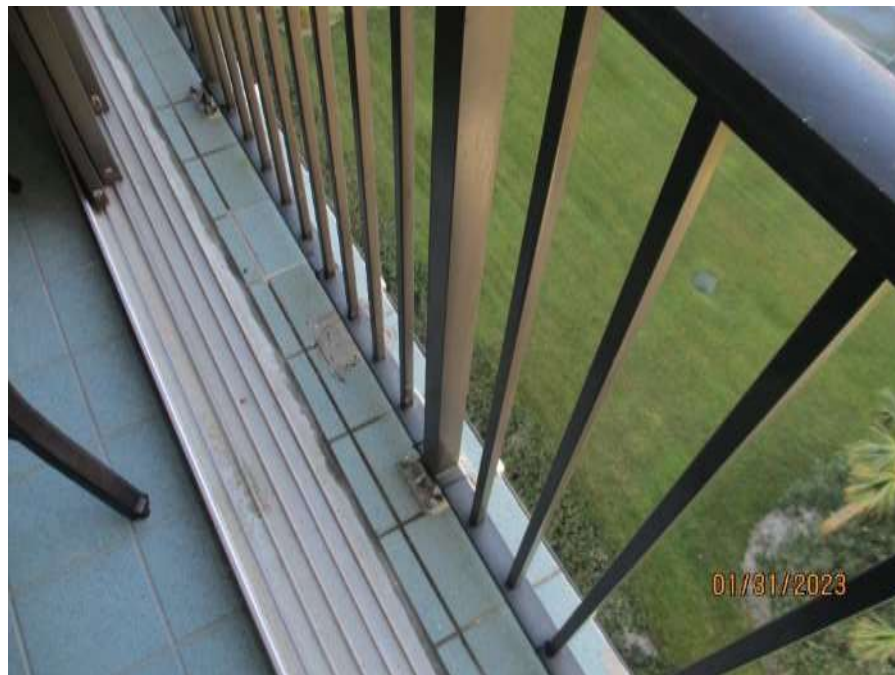
**Photo #10** – Typical Balcony with No Balcony Waterproofing (Railings installed on top of existing tile)

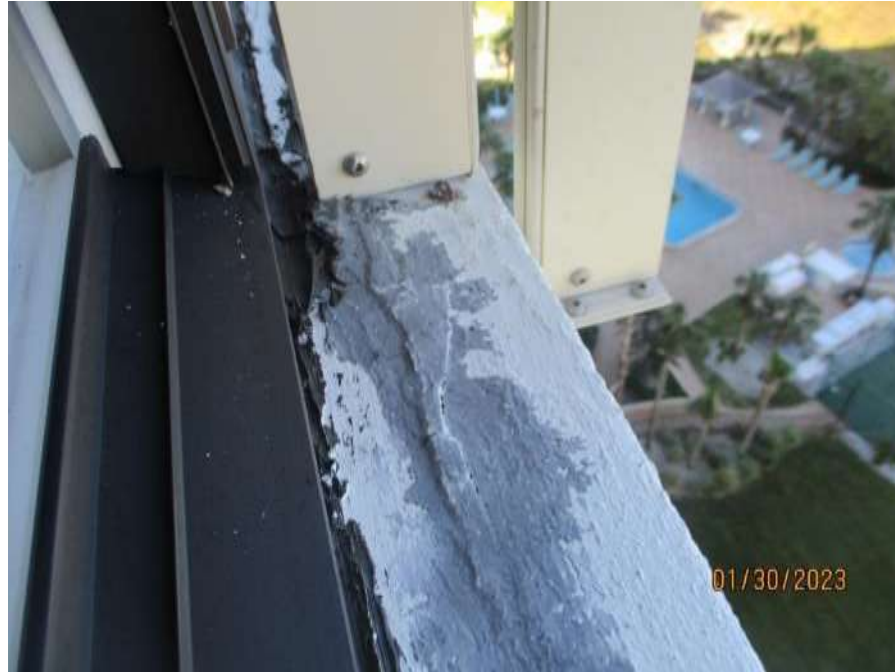
**Photo #13** – Damaged Window Sill w/ Previous Repair. Unsealed Fasteners into Sill

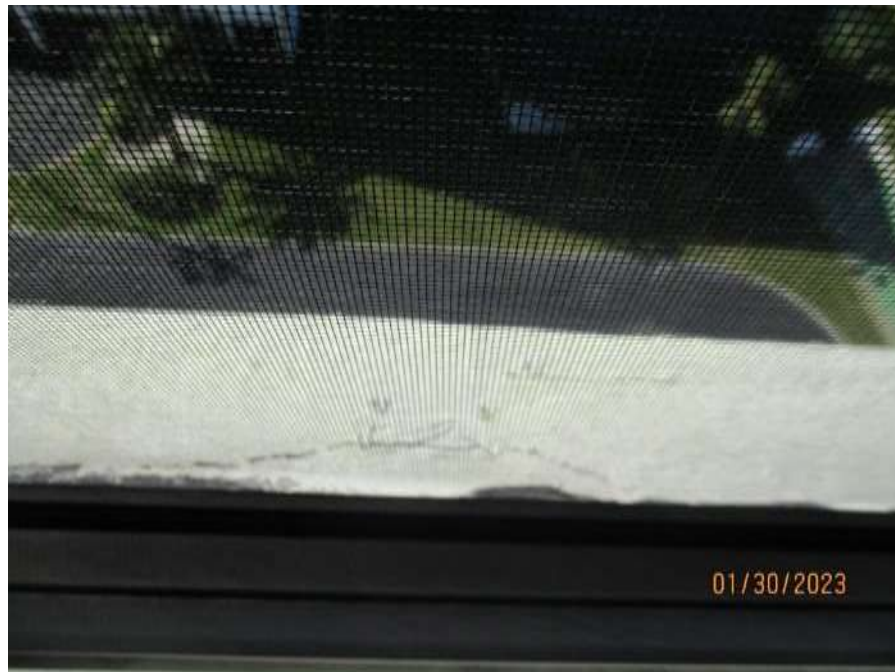
**Photo #14** – Typical Cracked Window Sill

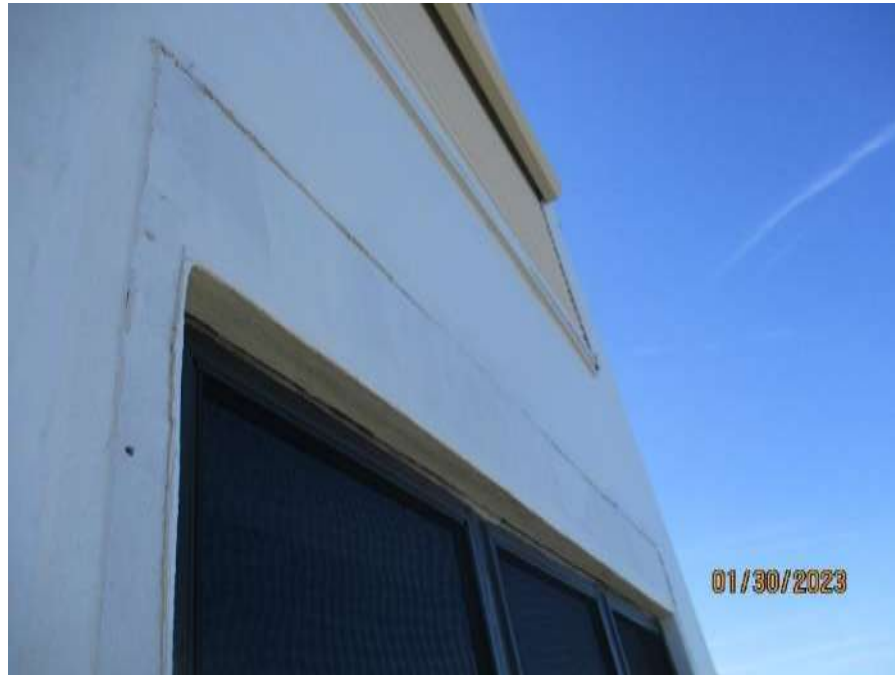
**Photo #15** – 1201 West Elevation Window Header Cracked and Delaminated Stucco, Unsealed Fastener Holes from Removed Shutter

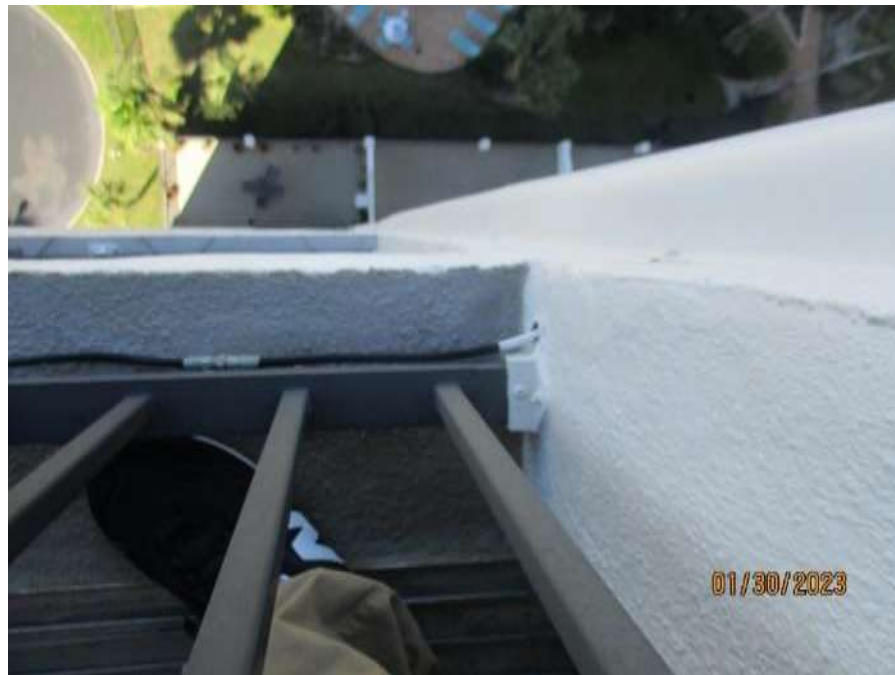
**Photo #16** – Typical Unsealed Cable TV Wall Penetration

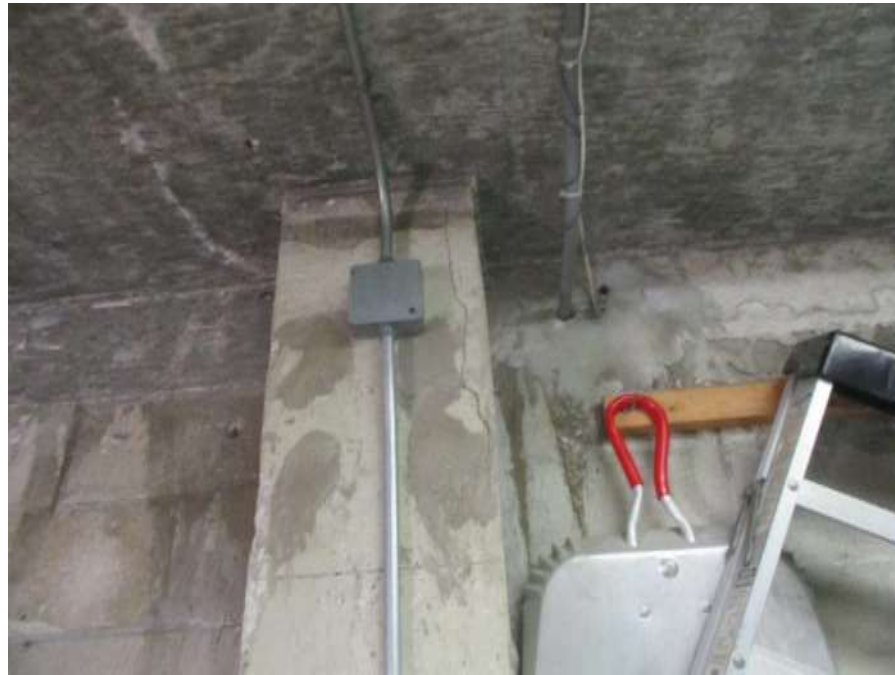
**Photo #17** – Isolated Spalling Concrete at Column in Maintenance Room

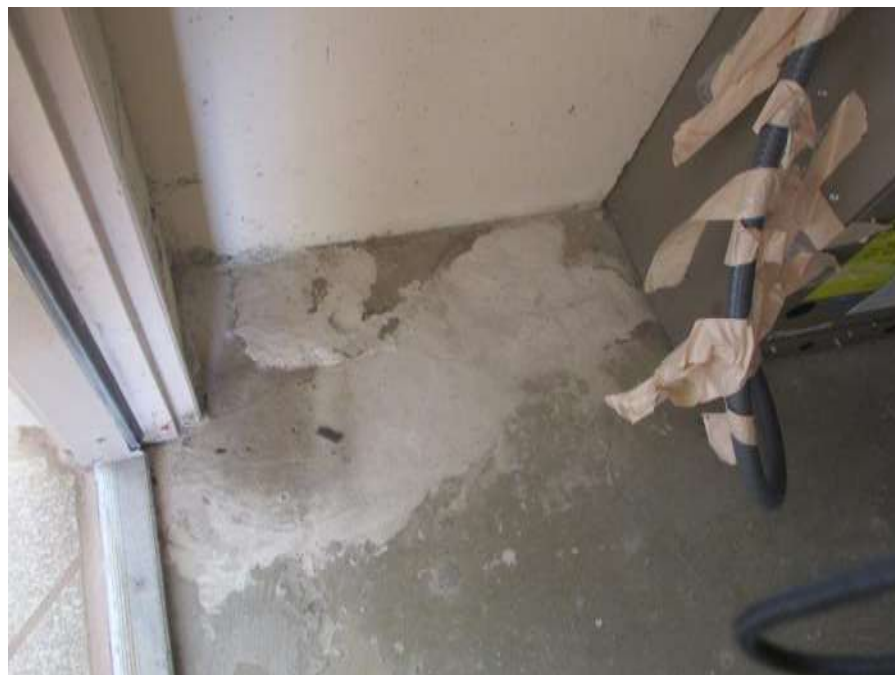
**Photo #18** – Typical Spalling Concrete and Failed Previous Repair at Utility Closet

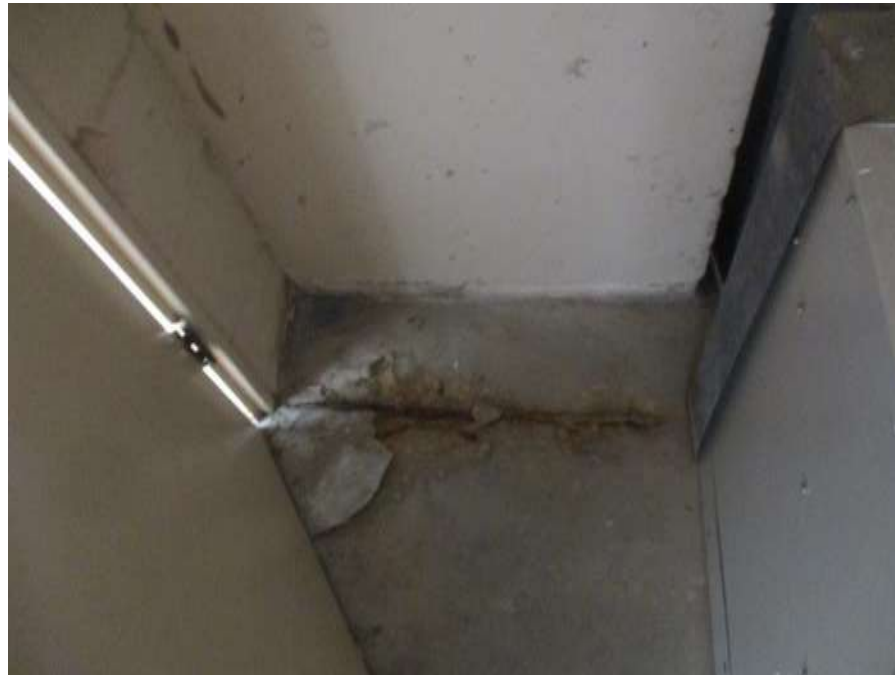
**Photo #19** – Typical Spalling Concrete at Utility Closet Threshold

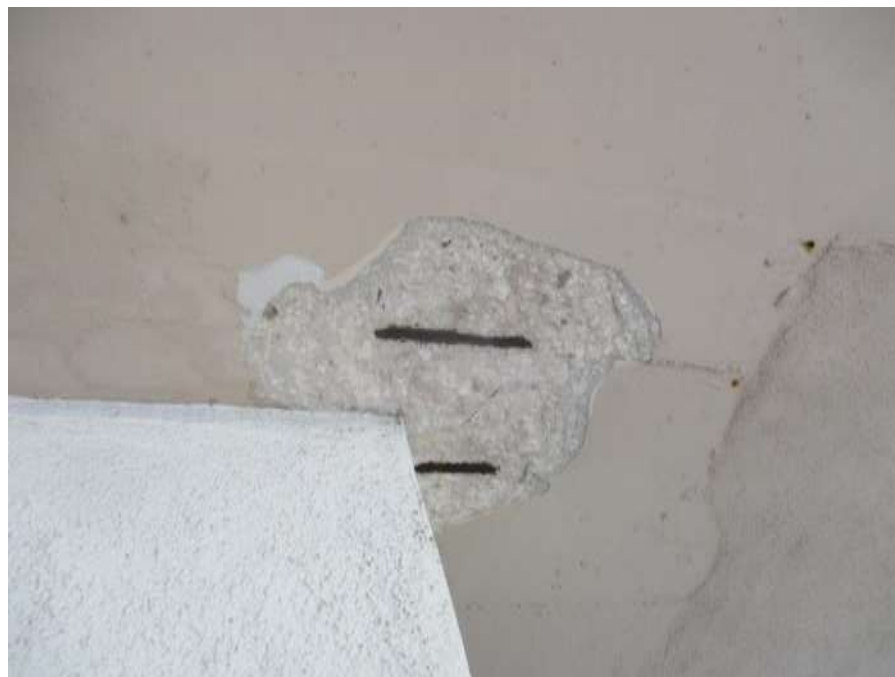
**Photo #20** – Spalling Concrete with Exposed Rusty Rebar

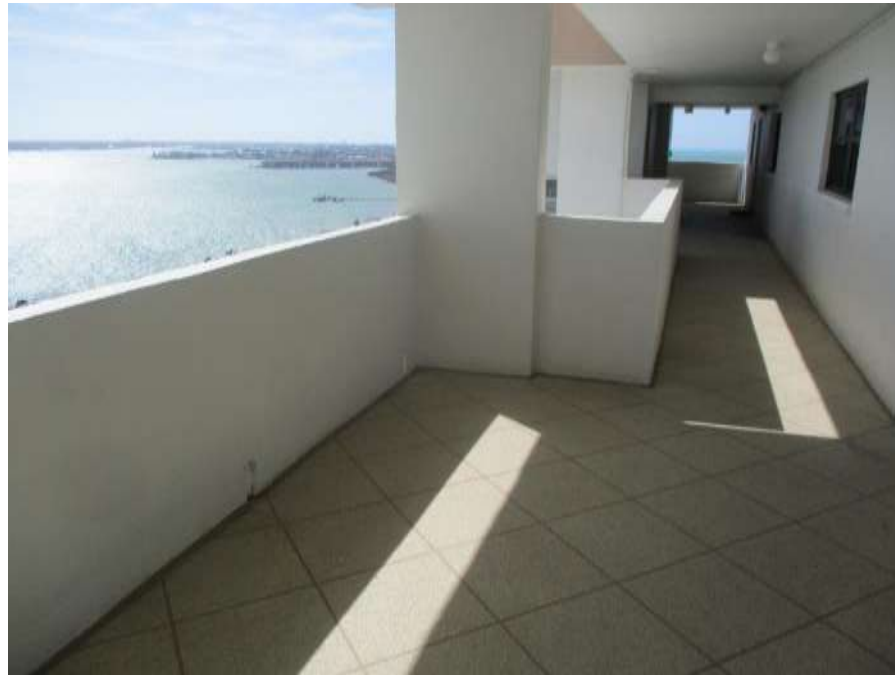
**Photo #21** – Typical Elevated Walkway and Guard Wall System

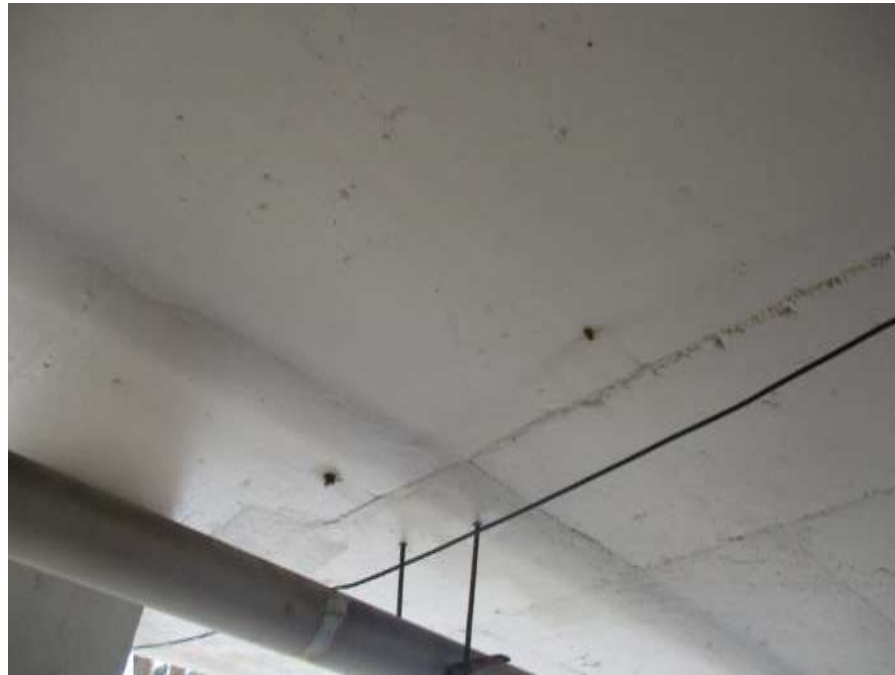
**Photo #23** – Abandoned/Broken Pipe Hangers with Corrosion in Garage Ceiling

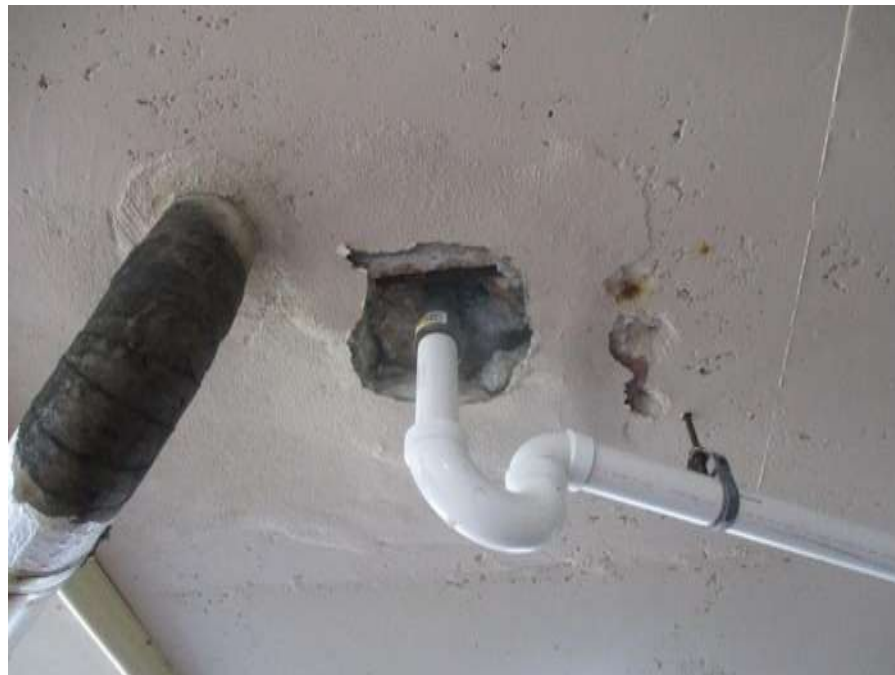
**Photo #24** – Isolated Concrete Spalling at Plumbing Penetration Garage Ceiling

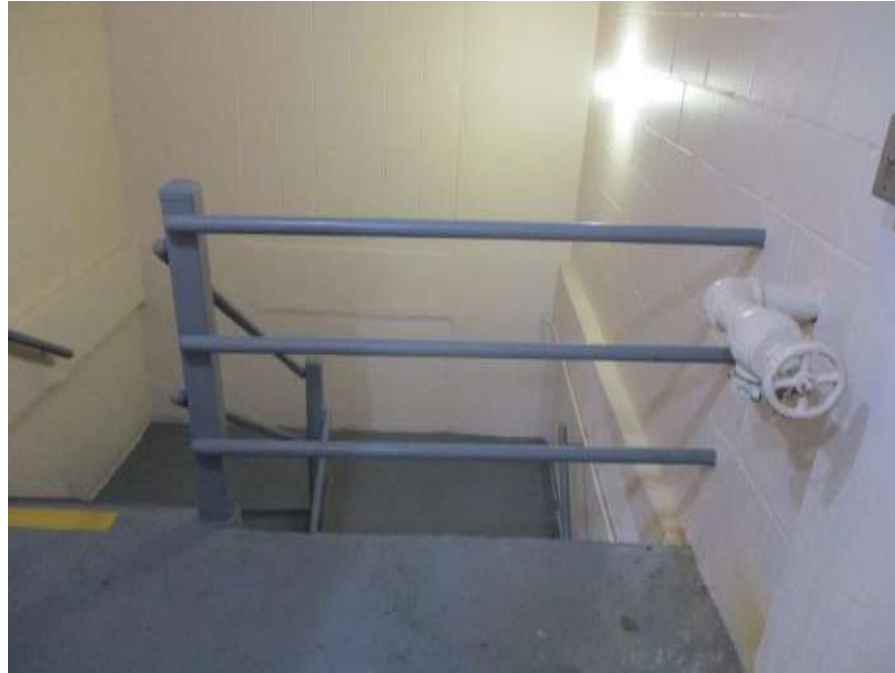
**Photo #25** – Typical Stair Tower Railing at Landing and Stairs

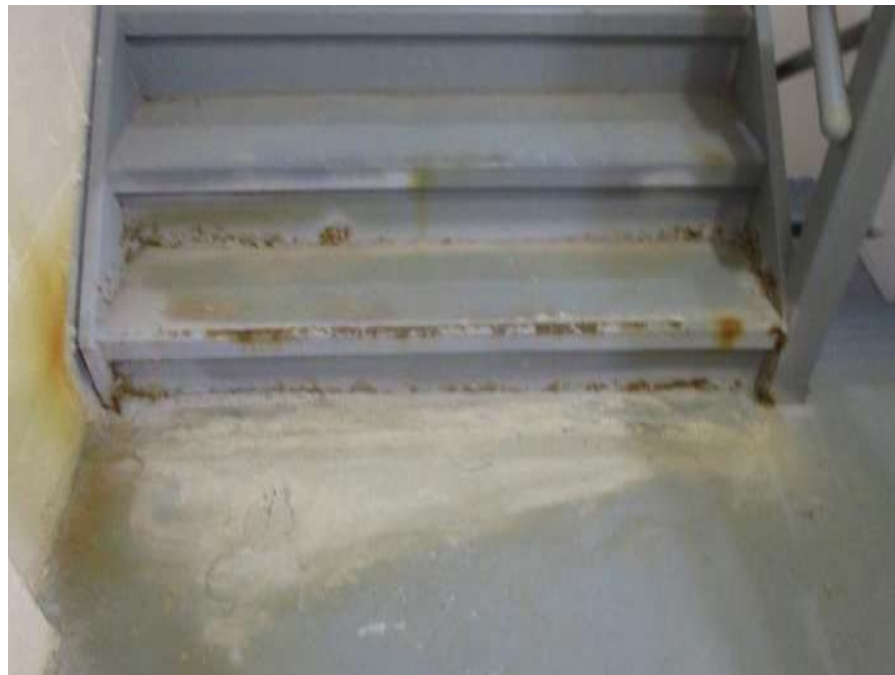
**Photo #26** – Typical Corrosion at Stair Treads

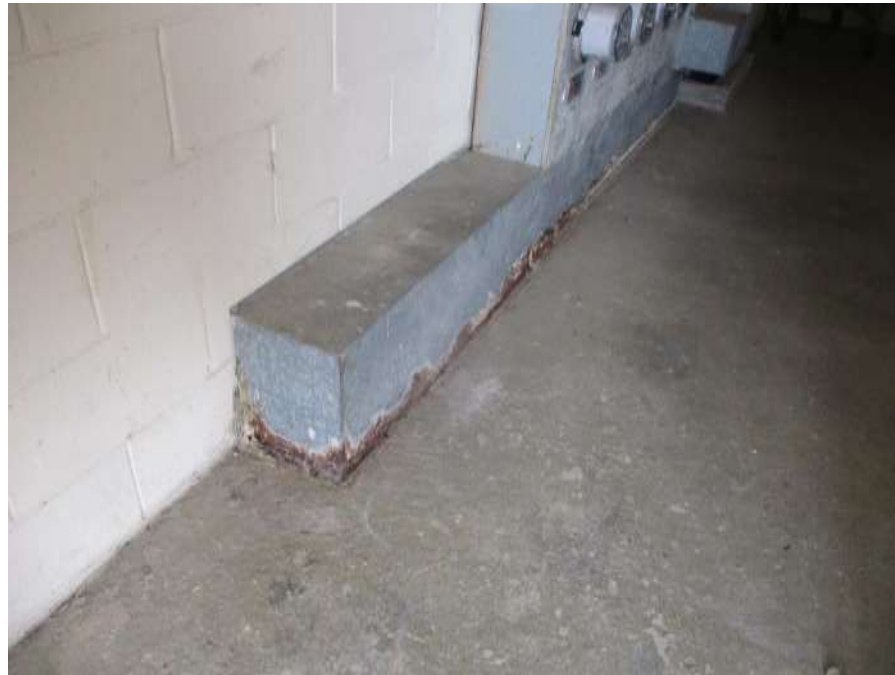
**Photo #27** – Typical Corrosion of FPE Meter Panel

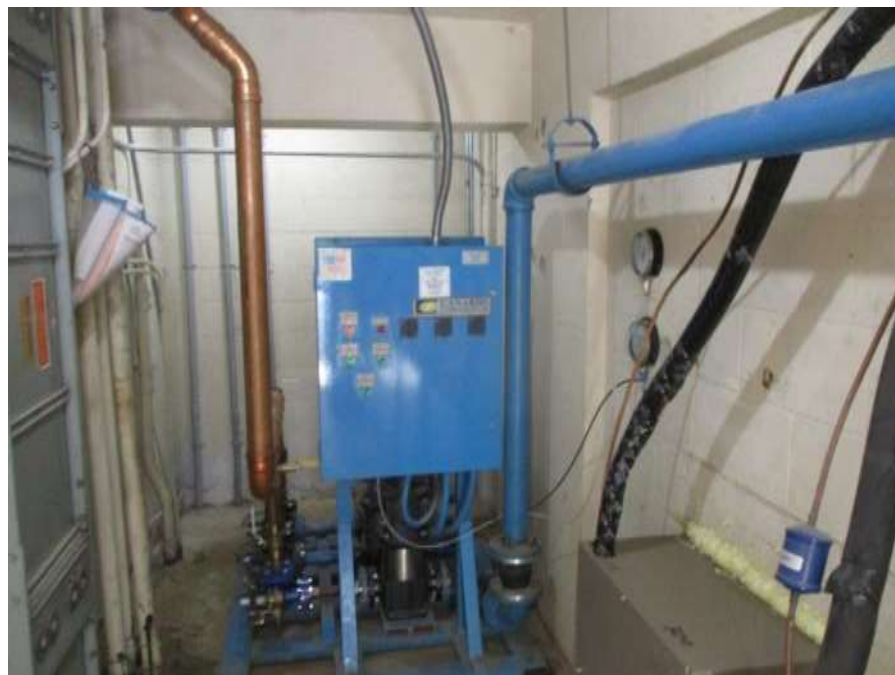
**Photo #28** – Domestic Water Equipment Visually in Working Order

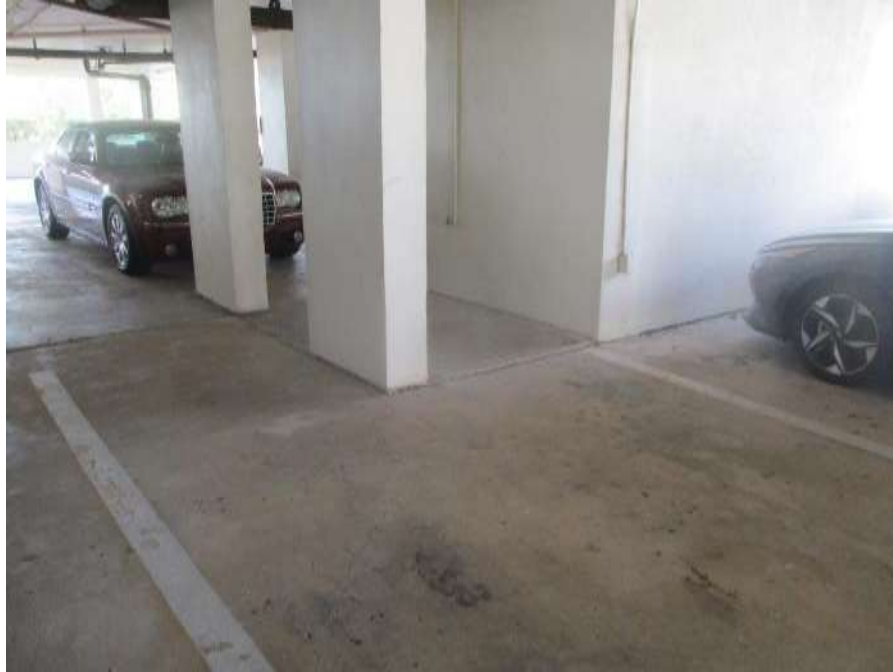
**Photo #31** – Settlement of Slab on Grade at Under Building Parking. Potential Trip Hazard due to Raised Portion of Slab at Control Joint

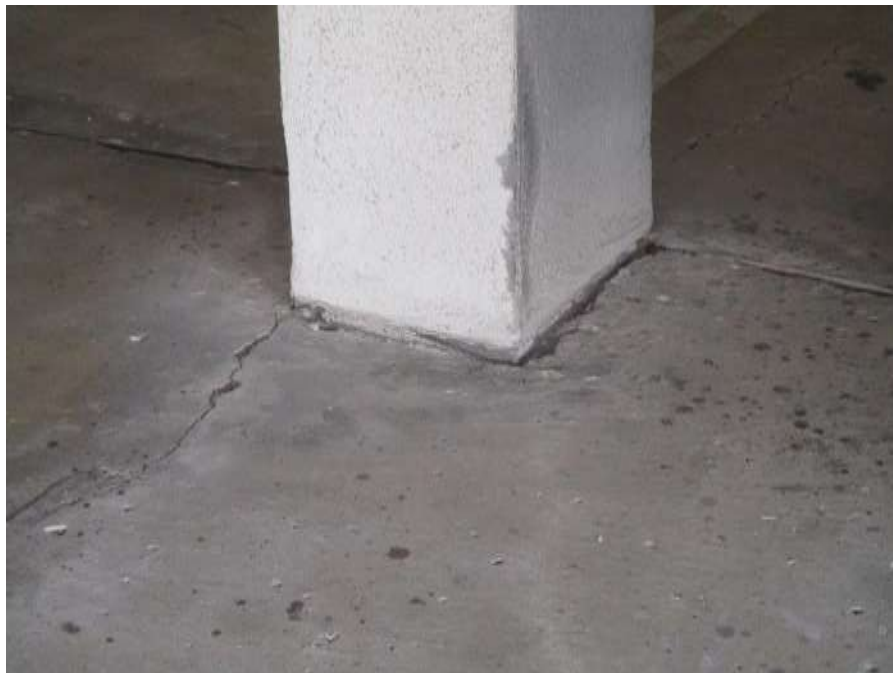
**Photo #32** – Evidence of Slab on Grade Settlement at Existing Column. Slab Lower than Column Stucco
