May 26, 2023

**RE: Landmark Towers 2 – Milestone Inspection Phase 1
1250 Gulf Boulevard, Clearwater, FL
KEG File# 23RT-0067**

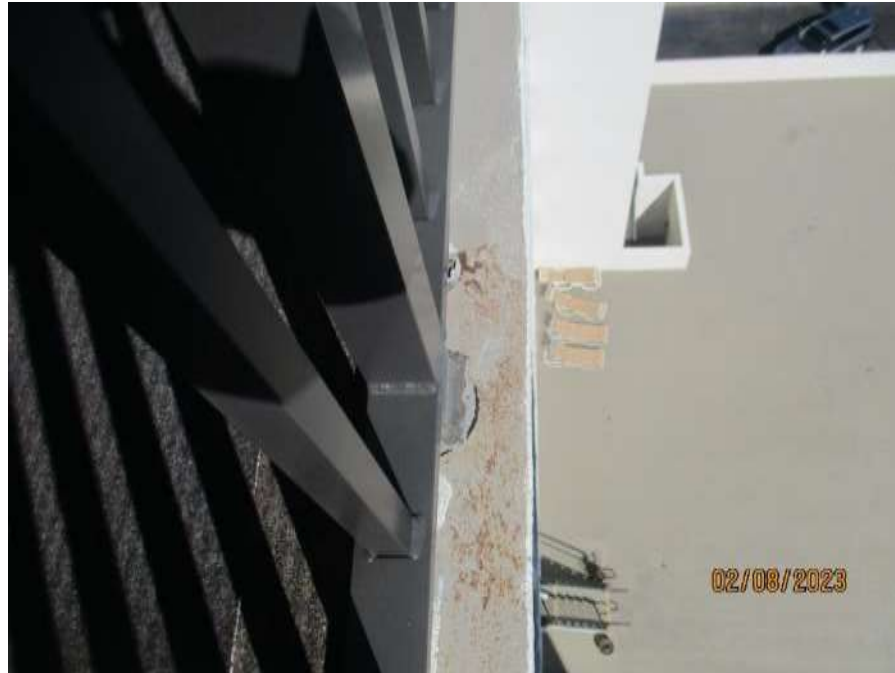
Post Pocket Below Slab Allowing Water to Pond and Damage to Slab Edge Waterproofing

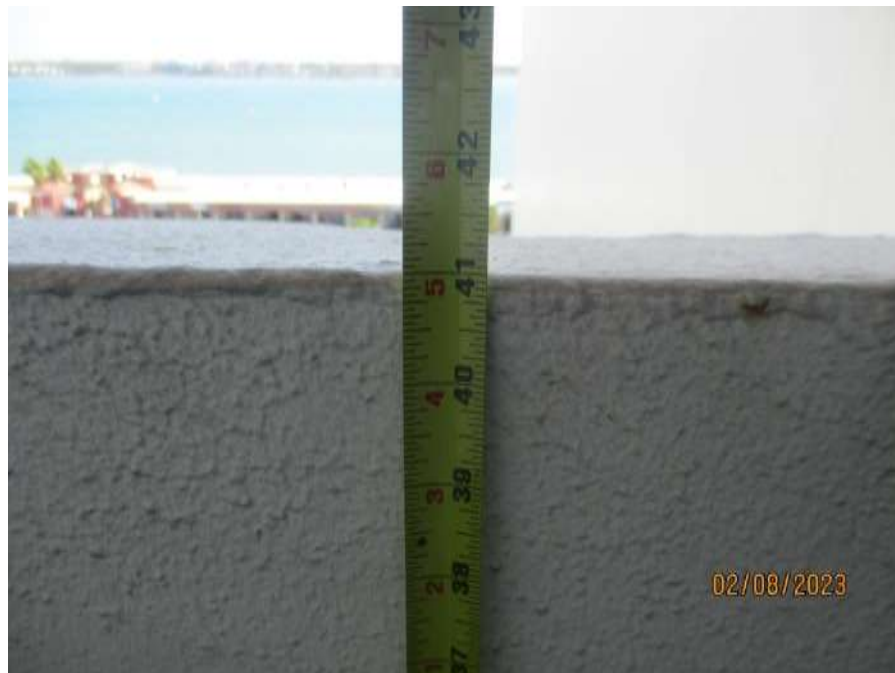
8. Guard Walls walkways in general, are in fair to good serviceable condition, however the elements do not meet Florida Building Code height requirements. (42" Height)

Typical Walkway Guard Wall Height = +/- 41"

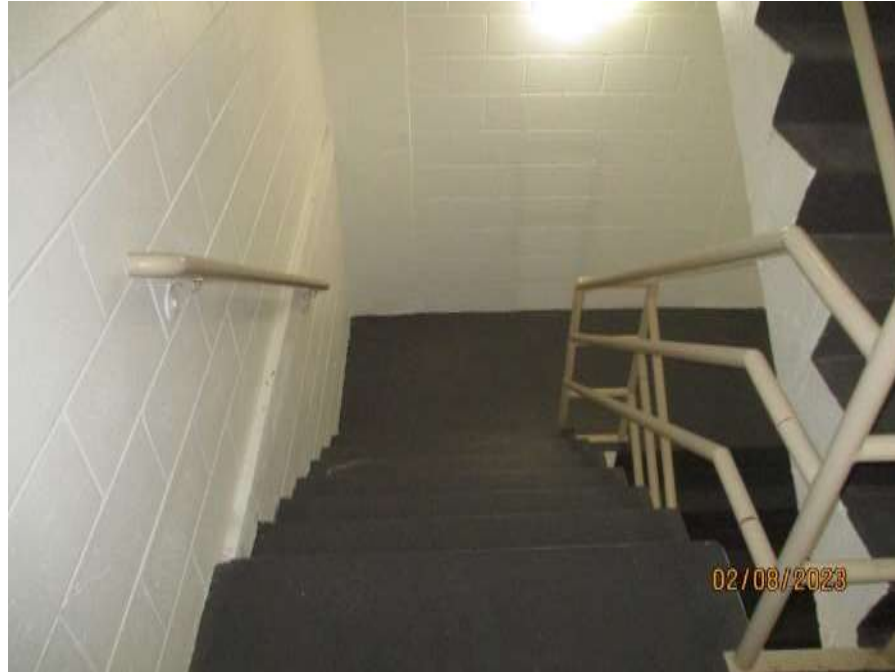
Typical Interior Stair Tower Railings

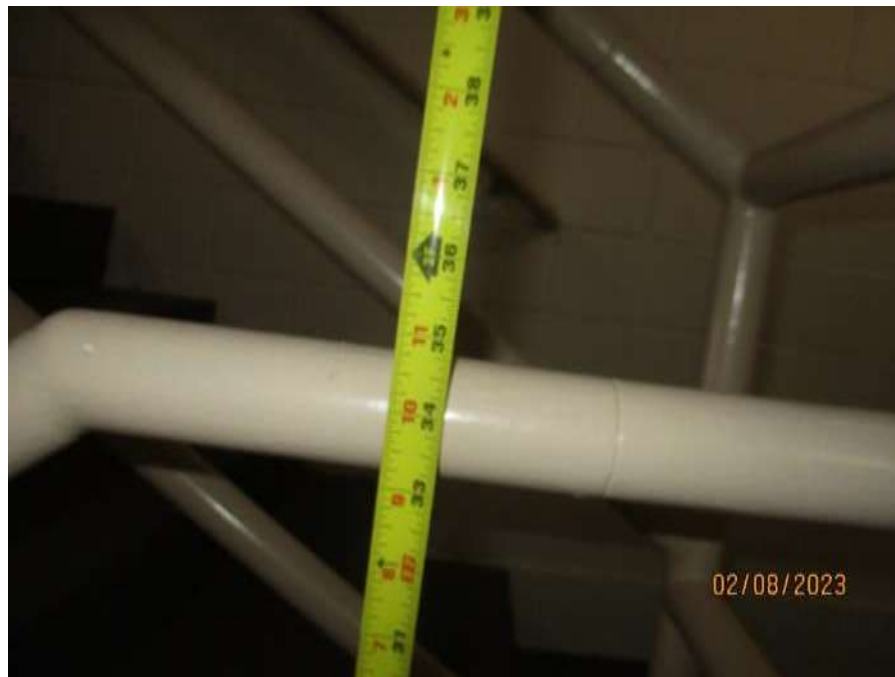
7. Railings at all stair towers, in general, are in fair to good serviceable condition however railings do not meet Florida Building Code height requirements, picket spacing requirements and do not have required grabrails. (42" Height, 4" Picket Spacing)

Typical Stair Tower Railing Height = +/- 35"

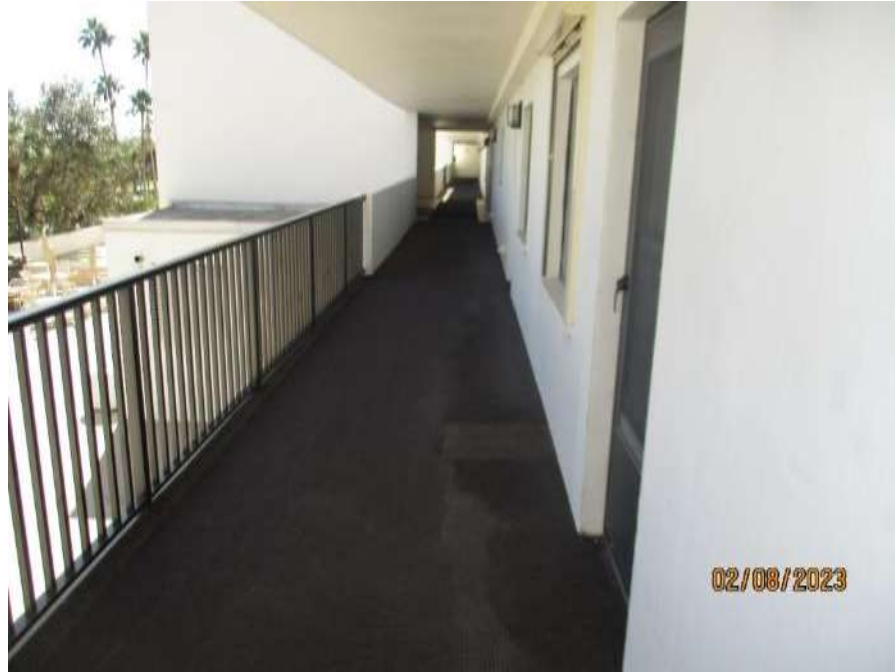
Apparent Water Ponding Staining at 3rd Level Walkway

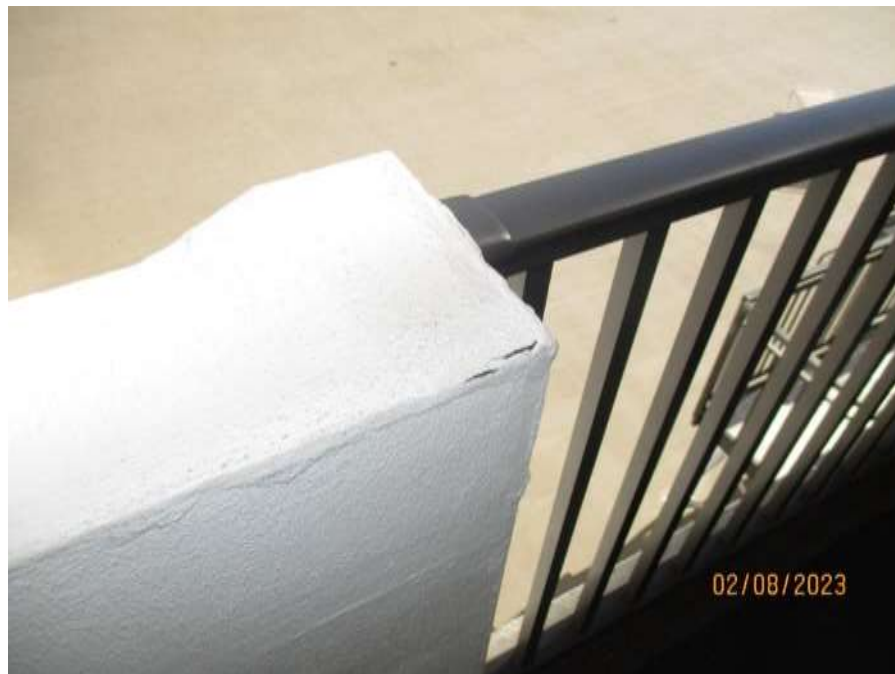
Stucco and Sealant Damage at Guard Wall to Railing Transition

6. Inspect and seal, as necessary, all penetrations attached to any exterior building envelope. This includes light fixtures, electrical outlets and railing brackets and cable tv penetrations at balconies.

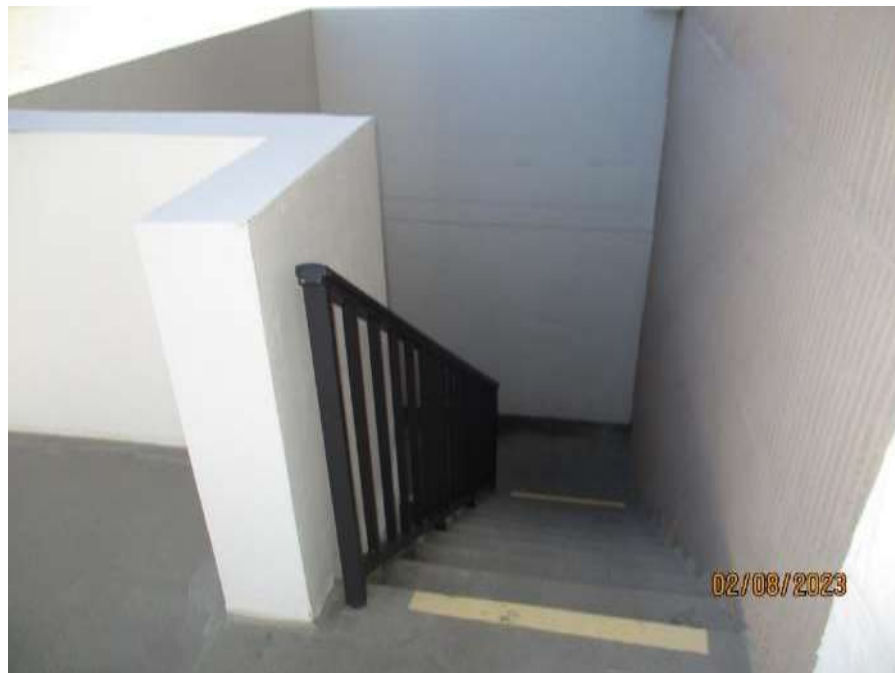
Typical Terrace Deck Stairs to Garage with Non Code Complaint Railings (36" Height 6" Picket Spacing)

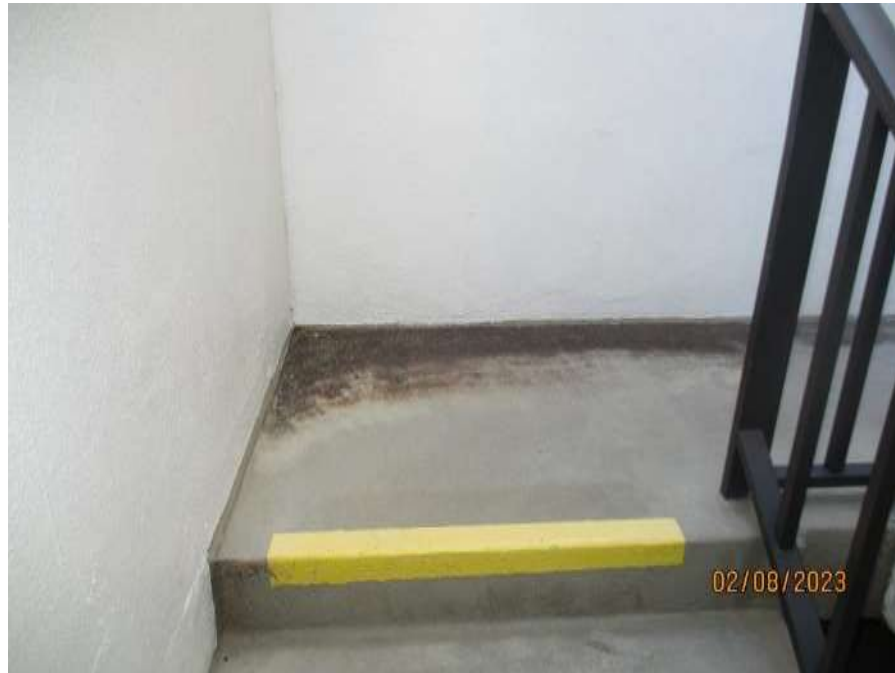
Ponding Staining at Stair Landing

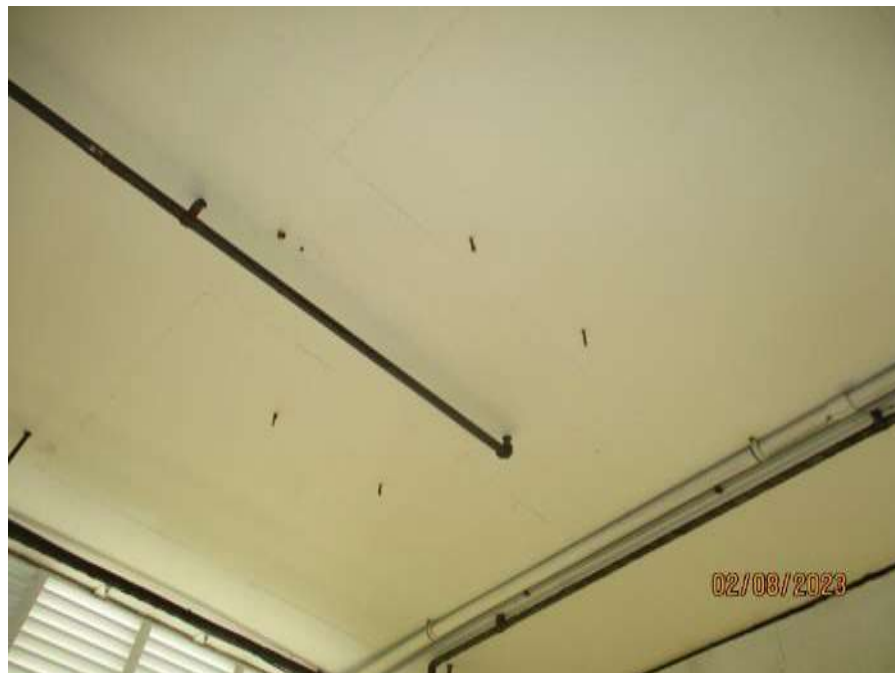
Abandoned Corroded Metal Pipe Hangers Remain in Ceiling

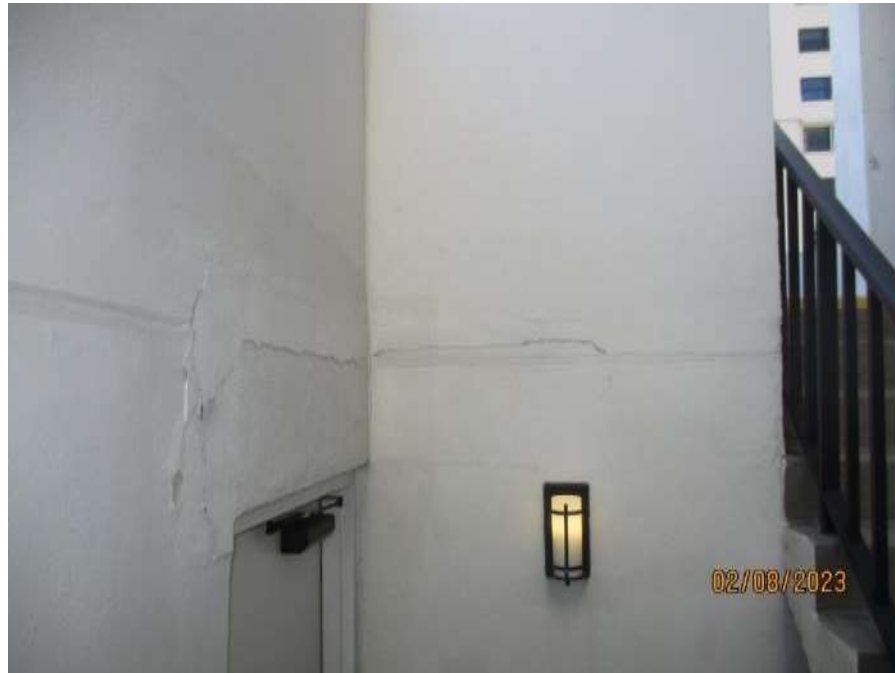
1. Spalling concrete and failed previous concrete repairs were observed at isolated areas of the 2nd floor elevated terrace deck and stairs the service the terrace deck from the parking garage. It is recommended that all damaged concrete be repaired in accordance with ICRI and ACI specification.

Cracking Stucco and Spalling Concrete at Terrace Deck Stairs (South)

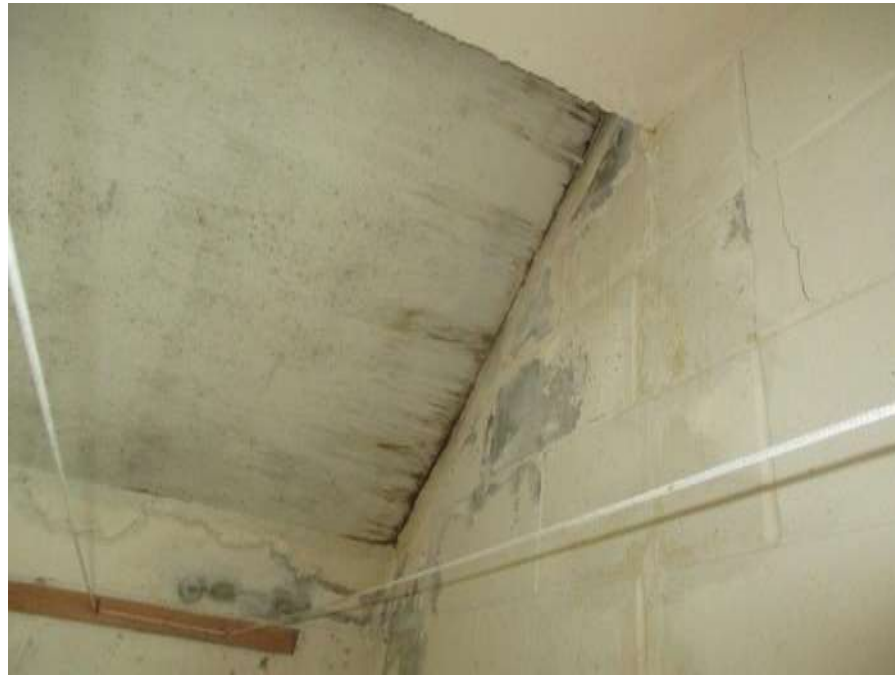
Water Intrusion Indicators into Balcony Closet

with evidence of active water intrusion at several balcony closet locations. Due to the existing design of the roof deck, it is recommended that the existing apparent liquid applied roofing system be removed and replaced with a new code compliant liquid applied roofing system such as Sikalastic Roofpro which can be installed over existing designed plywood roof deck configuration.

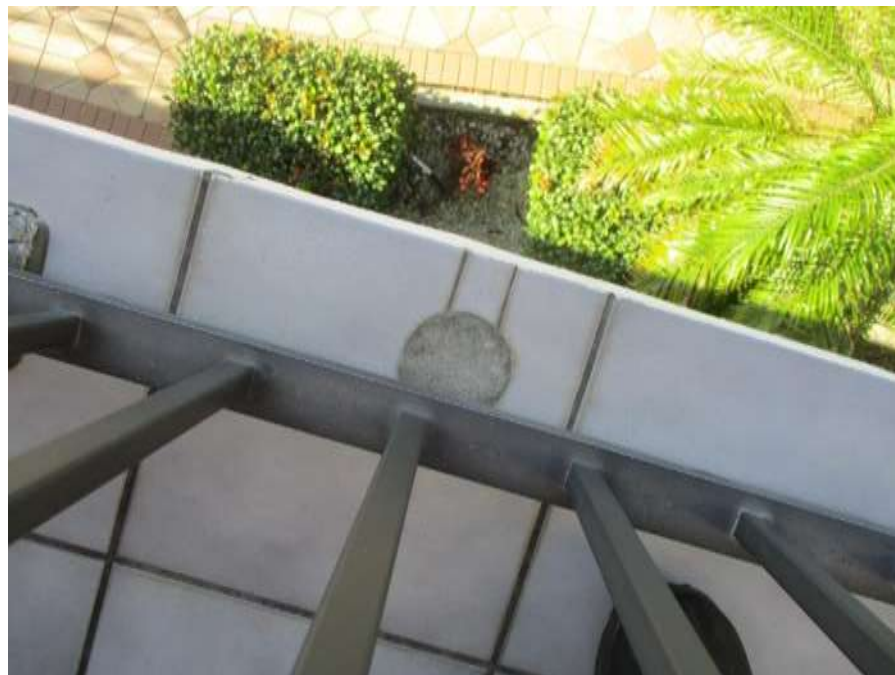
Typical Original Tile at Balcony With Old Post Pocket from Original Railing.

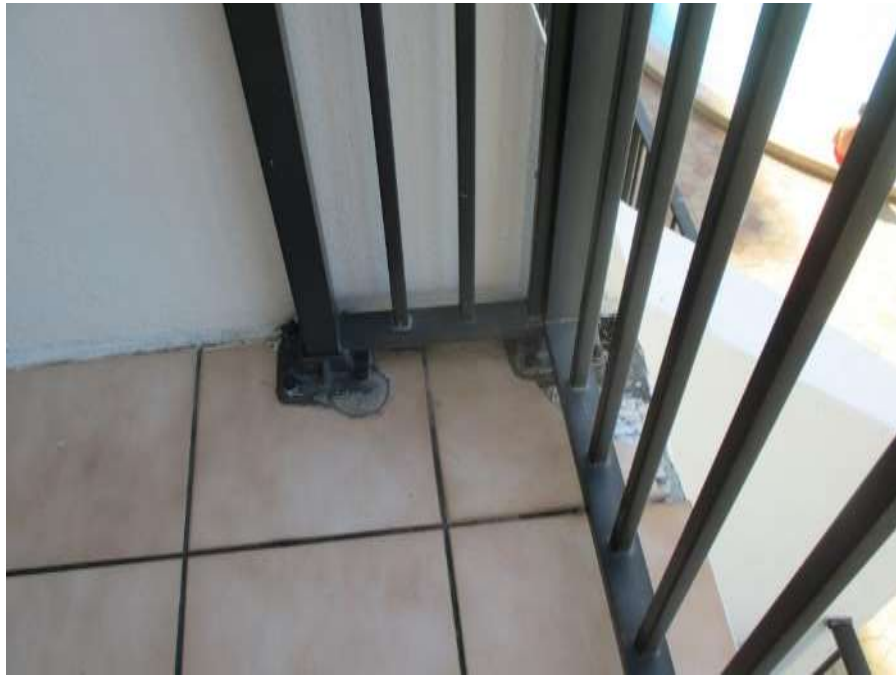
3. Existing waterproofing membranes on balconies appear to be approaching the end of useful life. It is recommended that all reinforced concrete in proximity to the Gulf of Mexico be protected with liquid applied urethane membrane due to the corrosive environment typical in coastal areas. It is recommended that all balconies be waterproofed, including all balconies with original or existing tile that pre-dated the installation of the newer style aluminum guard rails. It is KEGs understanding that at locations with original tile and/or tile installed prior to the installation of the balcony guardrails do not have a waterproofing membrane and/or the time elapsed since the tile install exceeds any reasonable warranty period or useful life of typical materials used for these applications.

Original Tile Damaged Exposing Slab Edge with No Apparnet Waterproofing Under Tile

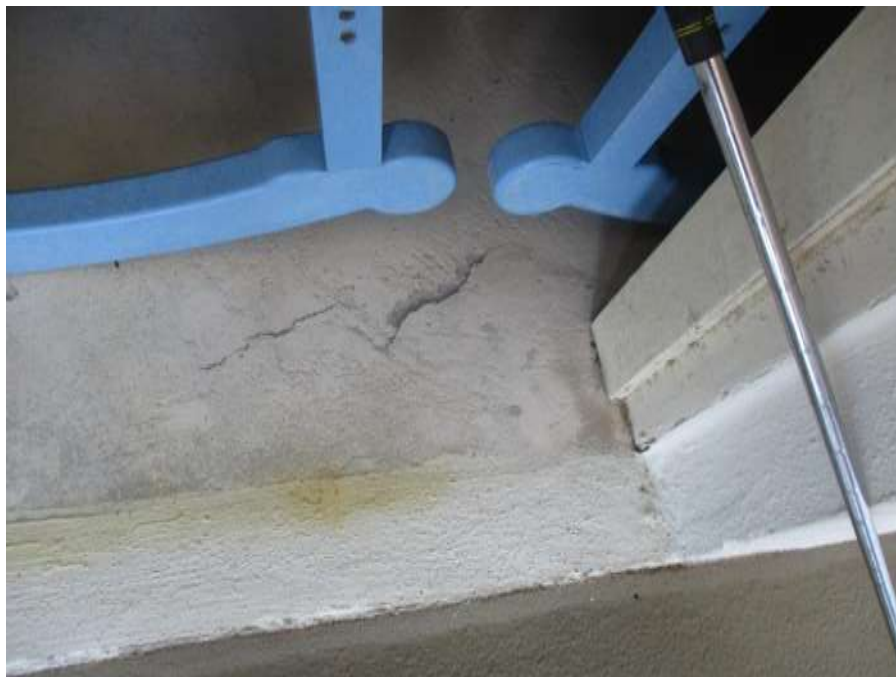
2. Spalling concrete and failed previous concrete repairs were observed at isolated locations at select balconies and the under-building parking area. It is recommended that all damaged concrete be repaired in accordance with ICRI and ACI specification.

Typical Isolated Concrete Spall in Balcony Closet

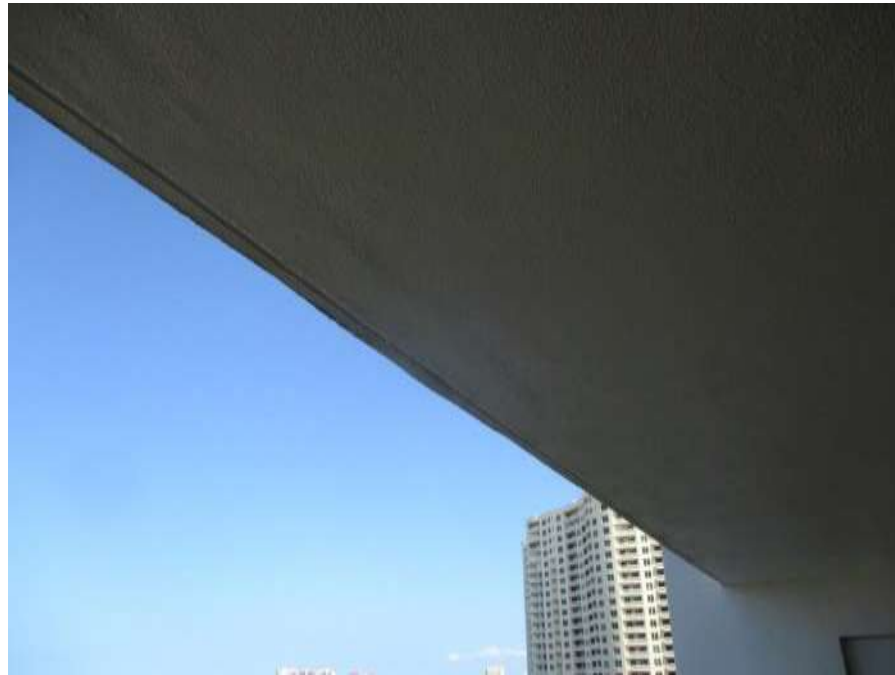
Sapling Concrete at Slab Edge

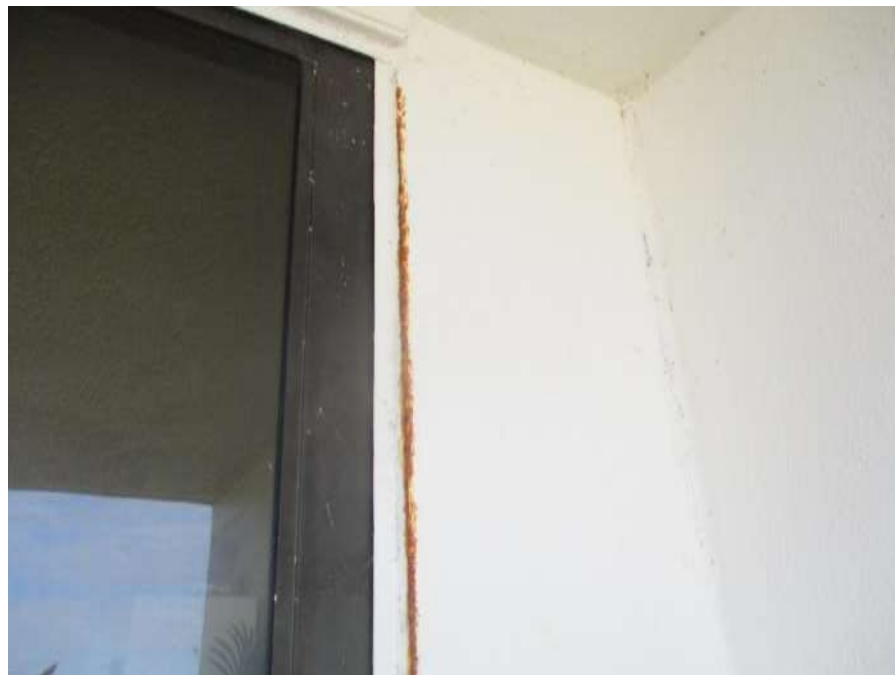
Rusted Corner Bead Stucco Accessory

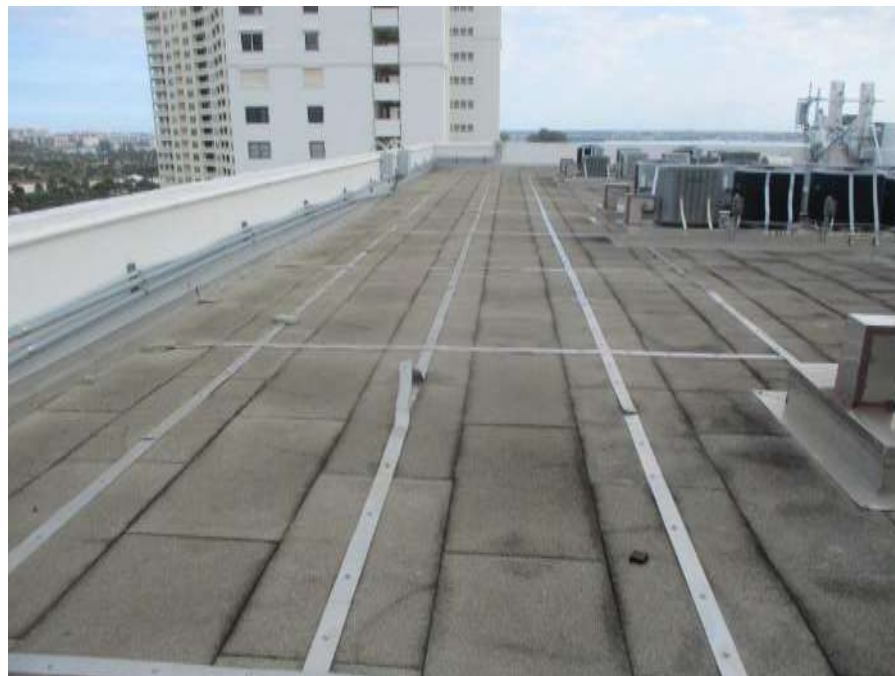
1. Observations of the IRMA (Inverted Roofing Membrane Assembly) found several locations with damage to the designed metal strapping holding down the Protected Membrane Roofing panels at the main roof of the building. It is recommended that the damaged strapping be repaired in accordance with the manufacturers guidelines to ensure the designed uplift restraint ability of the strapping remains as intended.
2. Sloped architectural roofs at west elevation of building which cover closer areas at balconies show signs of failure

Broken Strapping and Missing Fasteners at Roof System
