May 26, 2023

**RE: Landmark Towers 2 – Milestone Inspection Phase 1
1250 Gulf Boulevard, Clearwater, FL
KEG File# 23RT-0067**

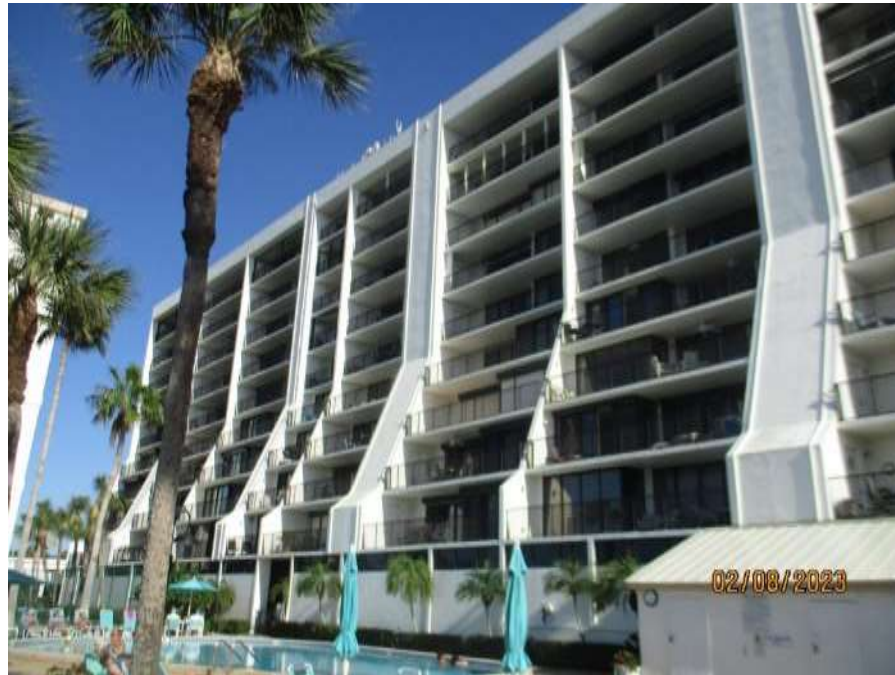
Rear Elevation of Building

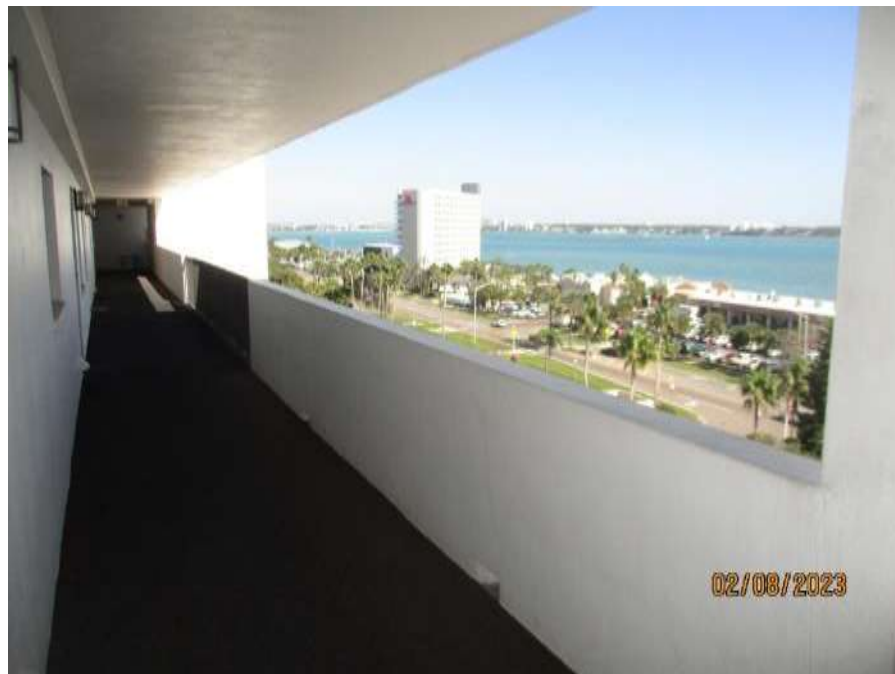
Typical Exterior Walkway

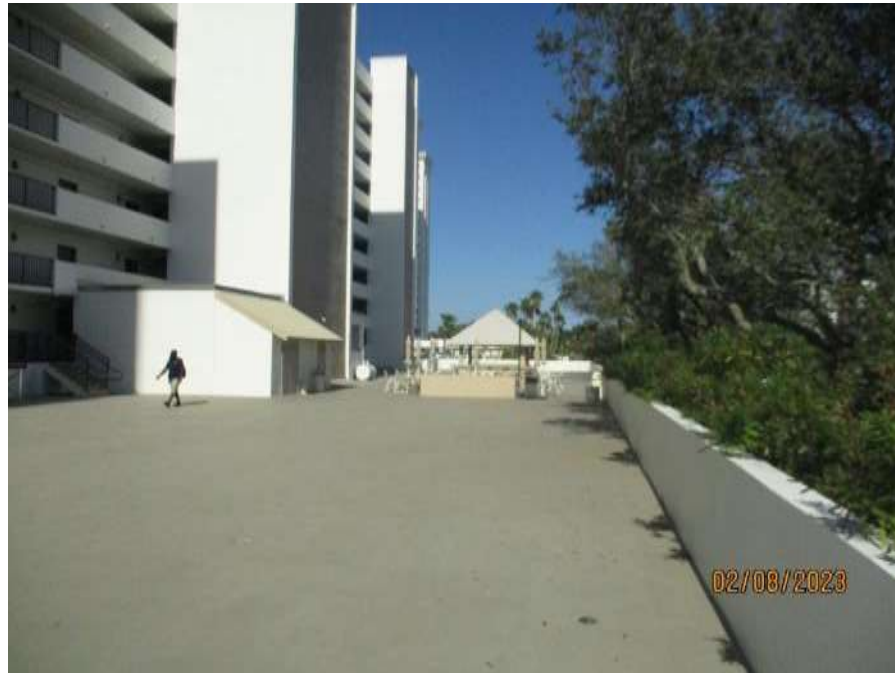
1. Spalling concrete and failed previous concrete repairs were observed at isolated areas of the 2nd floor elevated terrace deck and stairs the service the terrace deck from the parking garage. It is recommended that all damaged concrete be repaired in accordance with ICRI and ACI specification.

Elevated Terrace Deck at 2nd Floor

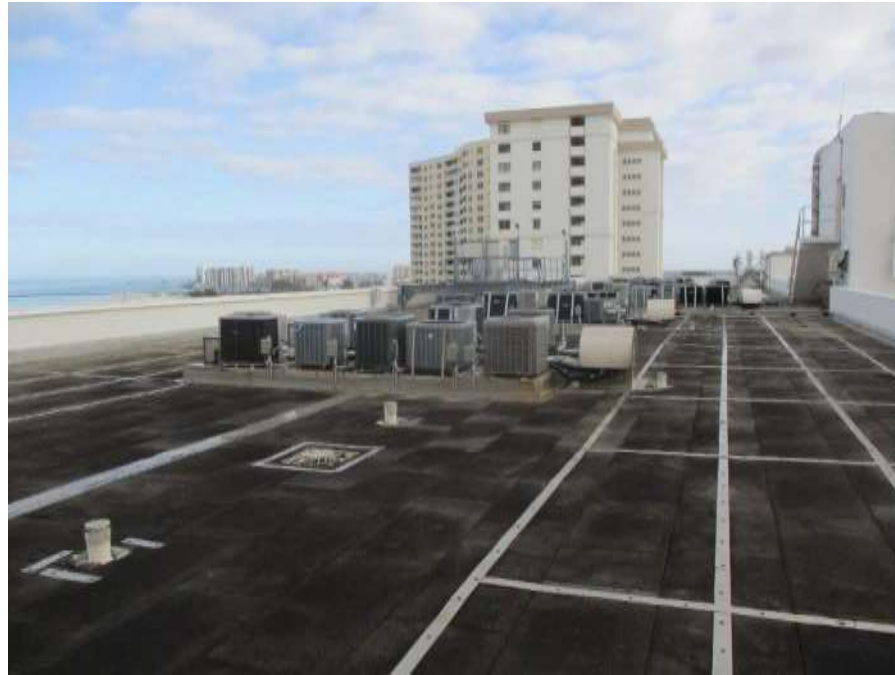
1. Observations of the IRMA (Inverted Roofing Membrane Assembly) found several locations with damage to the designed metal strapping holding down the Protected Membrane Roofing panels at the main roof of the building. It is recommended that the damaged strapping be repaired in accordance with the manufacturers guidelines to ensure the designed uplift restraint ability of the strapping remains as intended.
2. Sloped architectural roofs at west elevation of building which cover closer areas at balconies show signs of failure

Overview of Inverted Roofing Membrane System
